The electromagnetic brake comprises the assembly groups stator and armature.

Assembly information:

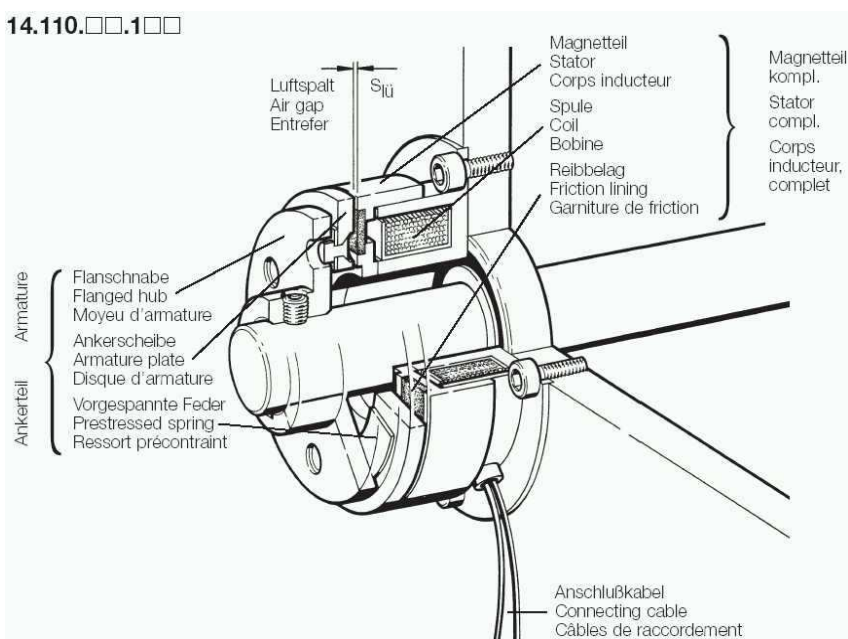
Screws, shakeproof washers and screw thread design to fix armature design 3 (using the springs of the armature plate) to the component that is to be braked.

The armature „1“ with flange hub is fastened using the setscrew. The armature plate of the armature „3“ is directly fitted to the part to be braked using the spring.
